Manhole Inspection Summary

Manhole # S11C1_004MH

Insp Date: **1/8/09 10:26 AM**

Location Address: **S Edgewood St.**

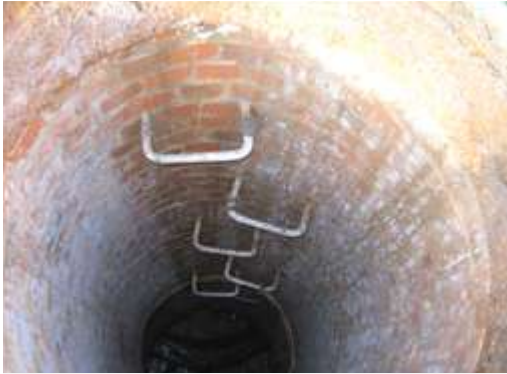
Defect 4

chimney infiltration

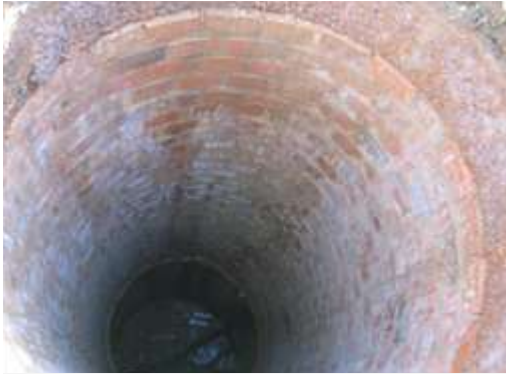
Defect 3

chimney infiltration

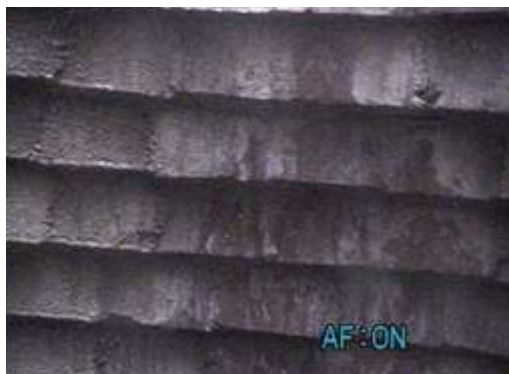
Defect 2

corbel infiltration

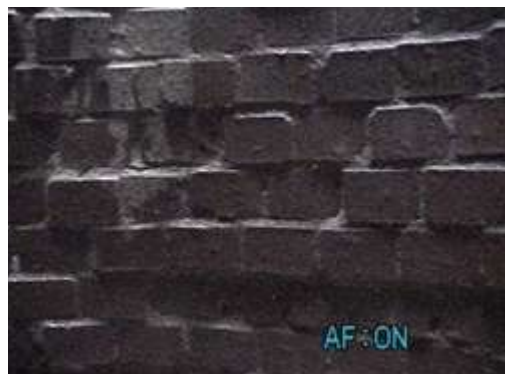
Defect 1

barrel infiltration

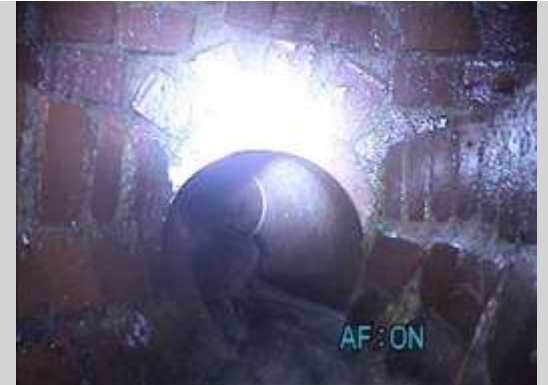
12 O'Clock Outflow

10 in. Circular Gravity Sewer
Pipe Out @ 12 O'Clock

Pipe Height: **10.8** (in.) Rod and Bar (Angled)
Pipe Material: **Clay** ☐ Pipe Lined
Invert Depth: **19.20** (ft.) Flow Characteristics: **Fast**
Deposits: ☒ None ☐ Mud ☐ Sludge ☐ Debris ☐ Grease
Silt Depth: **0** (in.) Deposits Extent:
Infiltration: **None** Pipe Seal Cond: **Sound**

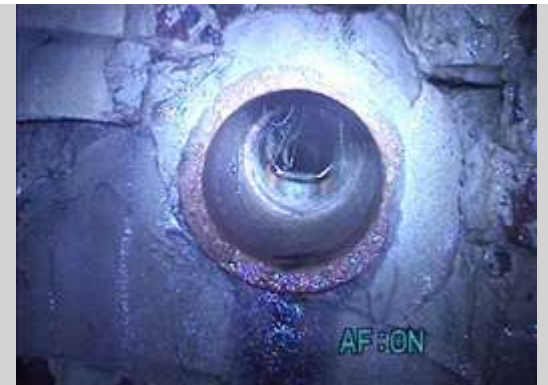
6 O'Clock Inflow

8 in. Circular Gravity Sewer
Pipe In @ 6 O'Clock

Pipe Height: **8.4** (in.) Rod and Bar (Angled)
Pipe Material: **Clay** ☐ Pipe Lined
Invert Depth: **11.10** (ft.) Flow Characteristics: **Slow**
Deposits: ☒ None ☐ Mud ☐ Sludge ☐ Debris ☐ Grease
Silt Depth: **0** (in.) Deposits Extent:
Infiltration: **None** Pipe Seal Cond: **Sound**

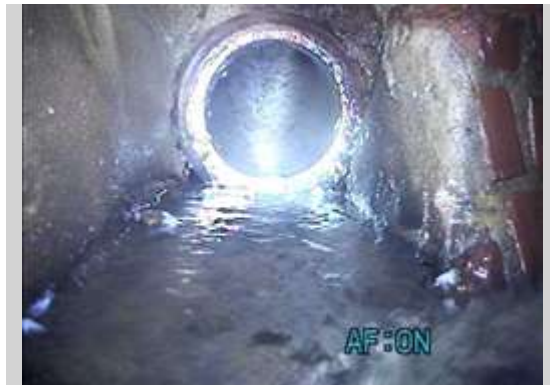
Drop In @ 6 O'Clock

Drop: **Outside** Rod and Bar
Angled: **Yes** Reading: **17.80** (ft.)
Inv Depth: **18.80** (ft.)

Drop Condition: **Open**

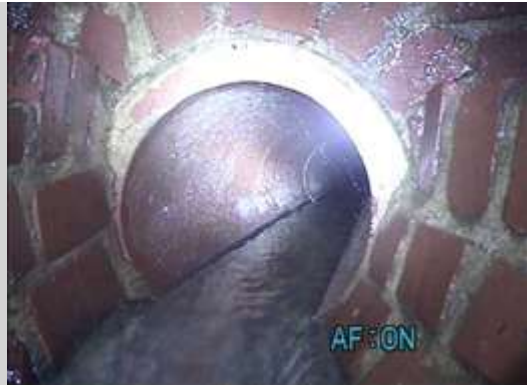
7 O'Clock Inflow

10 in. Circular Gravity Sewer
Pipe In @ 8 O'Clock

Pipe Height: **10.8** (in.) Rod and Bar (Angled)

Infiltration: **None** Pipe Seal Cond: **Sound**
